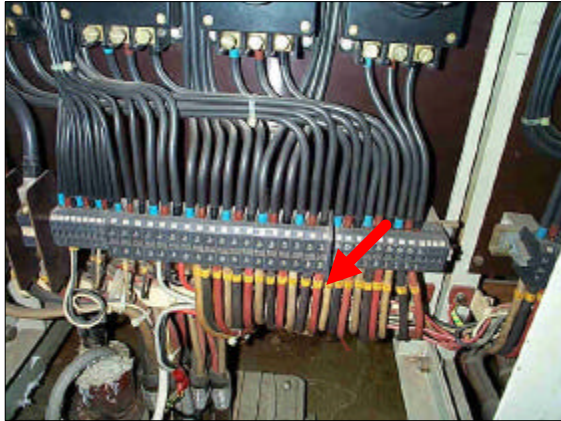
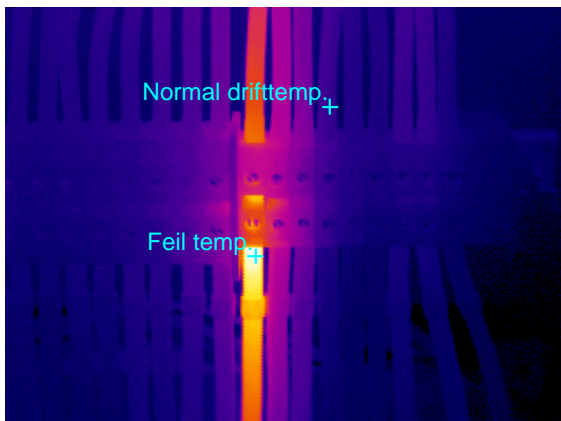
Sted	Emerg. Gen. room
Utstyr	EL.1061. Plint 31-32-33
Status	
Dato	5/19/00
Tid	11:32:07 AM

Temp. i feilsted	53 °C
Normal drift temp	31 °C
Overtemperatur	21 °C
Last i feilsted	
Merkelast	
Feilkategori	A

Ettertrekke forbindelser.

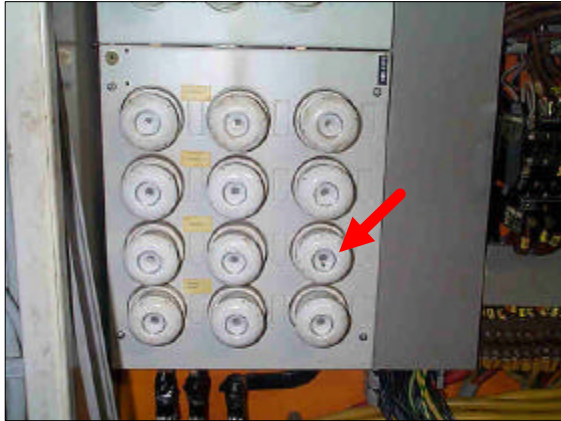
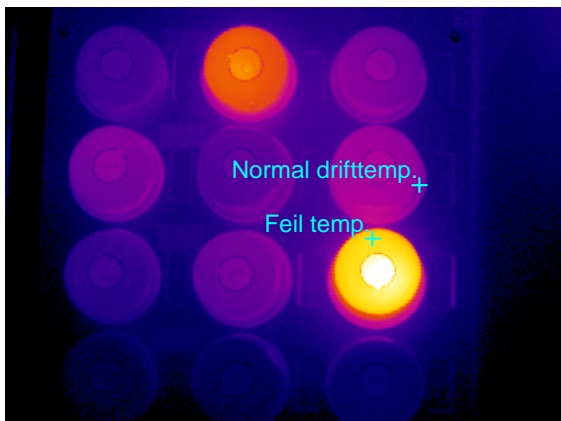
Sted	Maskinrom
Utstyr	Proviantanlegg.
Status	
Dato	5/19/00
Tid	8:48:05 PM

Temp. i feilsted	82 °C
Normal drift temp	44 °C
Overtemperatur	38 °C
Last i feilsted	
Merkelast	
Feilkategori	A

Kontrollere bunnskrue.
