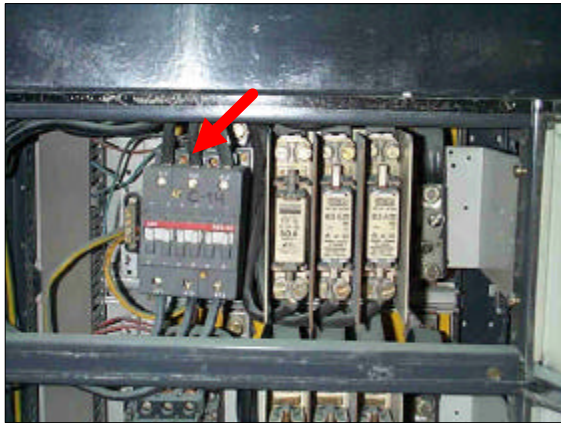
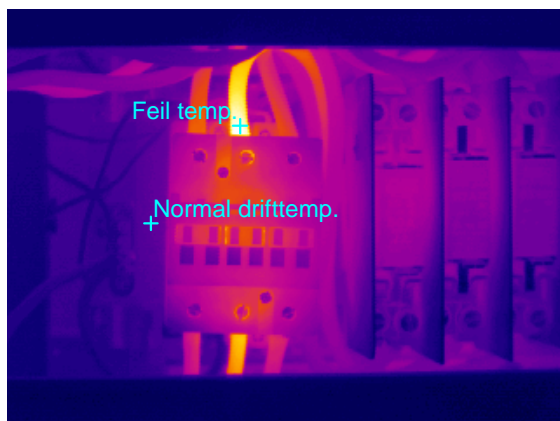
Sted	Varme 4- Hærdeovn
Utstyr	Kontaktor C14
Status	Dårlig kontakt
Dato	6/24/99
Tid	12:33:37 PM

Temp. i feilsted	78 °C
Normal drift temp	37 °C
Overtemperatur	41 °C
Last i feilsted	
Merkelast	63 Amp
Feilkategori	A

S- fas (midtre fas) ettertrekkes, samt kontaktflater kontrolleres.

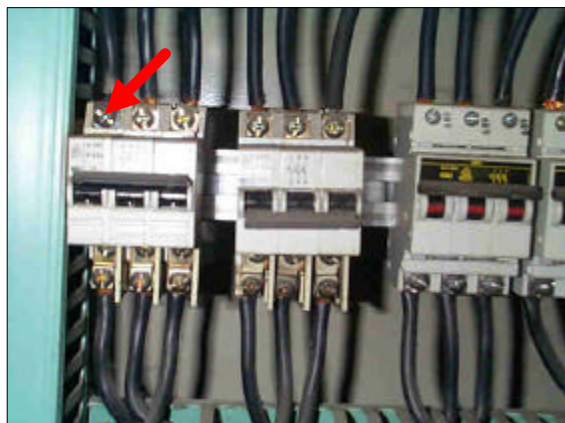
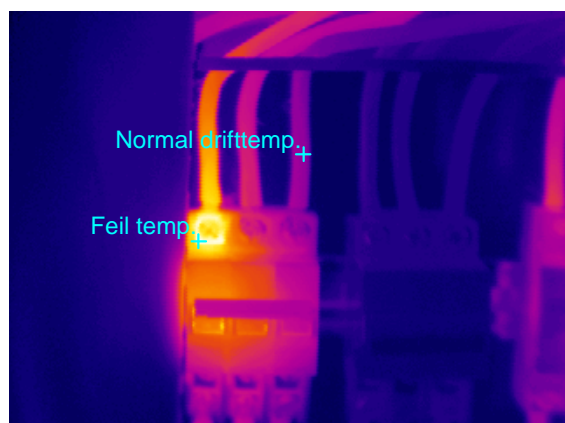
Sted	F7- M021
Utstyr	Sikr. automat nr. 1
Status	Dårlig kontakt
Dato	6/25/99
Tid	9:14:24 AM

Temp. i feilsted	165 °C
Normal drift temp	62 °C
Overtemperatur	103 °C
Last i feilsted	
Merkelast	63 Amp
Feilkategori	A

Ettretreke forbindelser.
Skifte ut ledere som har hatt høy temperatur.
